Manhole Inspection Summary

Manhole # S27Q1_005MH

Location Address: **900 W. Patapsco Ave.**

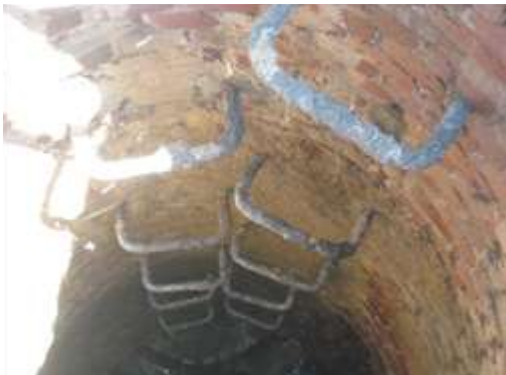
Steps

Count: **11** Missing: **0** ☒ **Corroded**

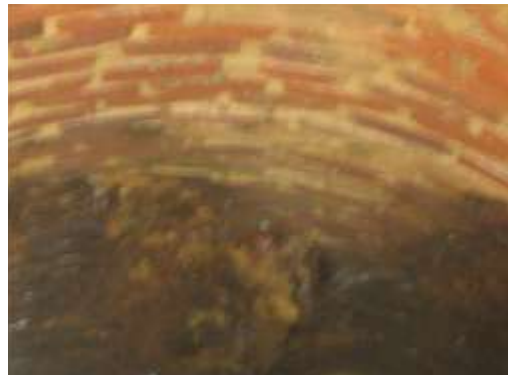
Defect 2

Condition: ☐ Sound ☒ **Cracked** ☐ Root Intrusion ☐ Loose Brick ☐ Deteriorated

Infiltration: ☐ None ☐ Joint ☐ Cracks ☐ Mortar ☐ Roots ☒ **Wall**

Infiltration through wall.

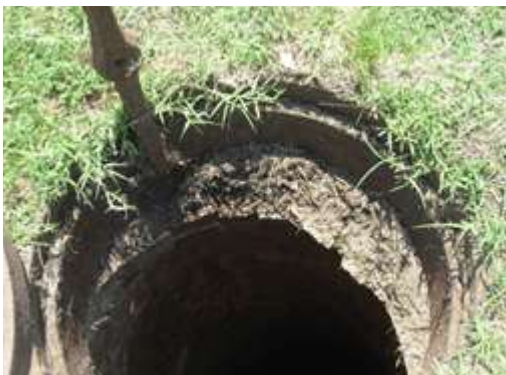
Defect 1

Offset: **4** (in.)

Frame offset

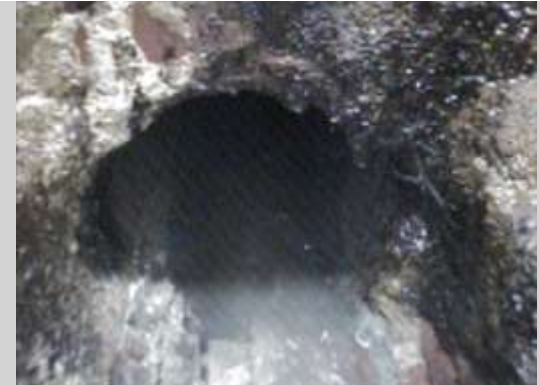
12 O'Clock Outflow

Pipe Height: **15.6** (in.) Rod and Bar (Angled)
Pipe Material: **Concrete** ☐ Pipe Lined
Invert Depth: **19.40** (ft.) Flow Characteristics: **Fast**
Deposits: ☒ None ☐ Mud ☐ Sludge ☐ Debris ☐ Grease
Silt Depth: (in.) Deposits Extent:
Infiltration: **None** Pipe Seal Cond: **Unknown**

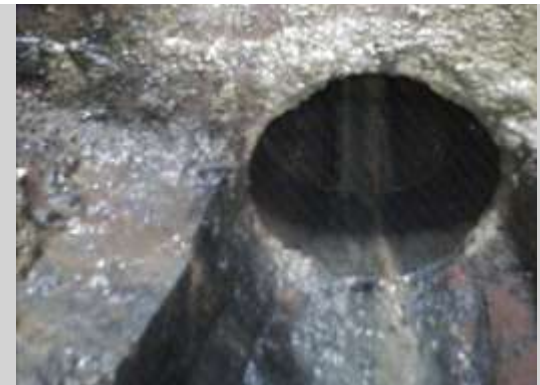
3 O'Clock Inflow

Pipe Height: **9.6** (in.) Rod and Bar (Angled)
Pipe Material: **Clay** ☐ Pipe Lined
Invert Depth: **18.38** (ft.) Flow Characteristics: **Fast**
Deposits: ☒ None ☐ Mud ☐ Sludge ☐ Debris ☐ Grease
Silt Depth: (in.) Deposits Extent:
Infiltration: **None** Pipe Seal Cond: **Sound**

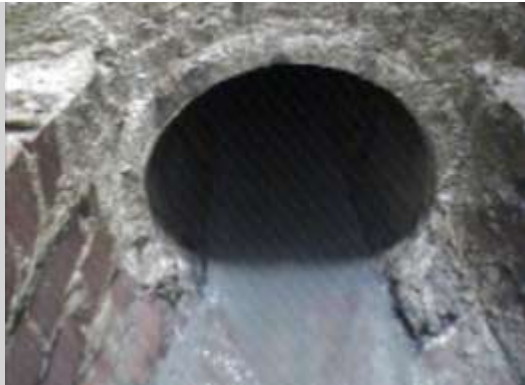
6 O'Clock Inflow

Pipe Height: **15.6** (in.) Rod and Bar (Angled)

Pipe Material: **Concrete** ☐ Pipe Lined

Invert Depth: **19.10** (ft.) Flow Characteristics: **Fast**

Infiltration: **None** Pipe Seal Cond: **Sound**

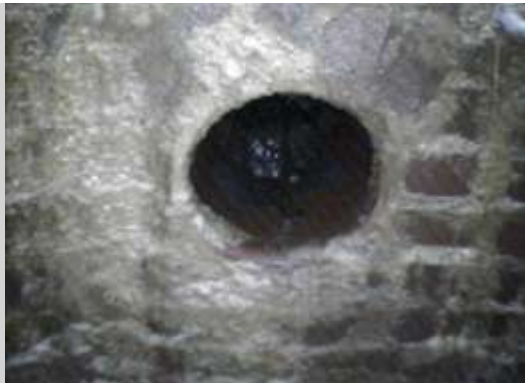
9 O'Clock Inflow

Pipe Height: **9.6** (in.) Rod and Bar (Angled)

Pipe Material: **Clay** ☐ Pipe Lined

Invert Depth: **17.12** (ft.) Flow Characteristics: **None**

Infiltration: **None** Pipe Seal Cond: **Sound**

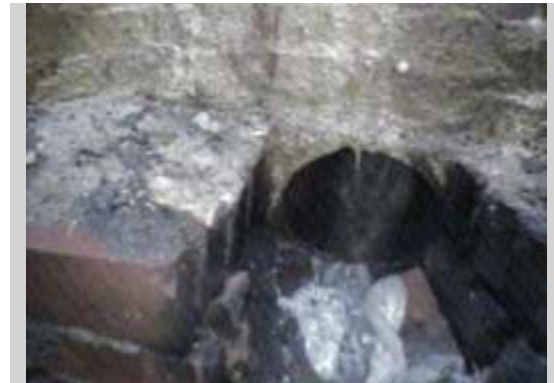
Drop In @ 9 O'Clock

Drop: **Outside** Rod and Bar
Angled: **Yes** Reading: **17.72** (ft.)
Inv Depth: **18.72** (ft.)

Drop Condition: **Open**
